## PRELIMINARY REPORT

### RAILROAD

### DCA15MR006

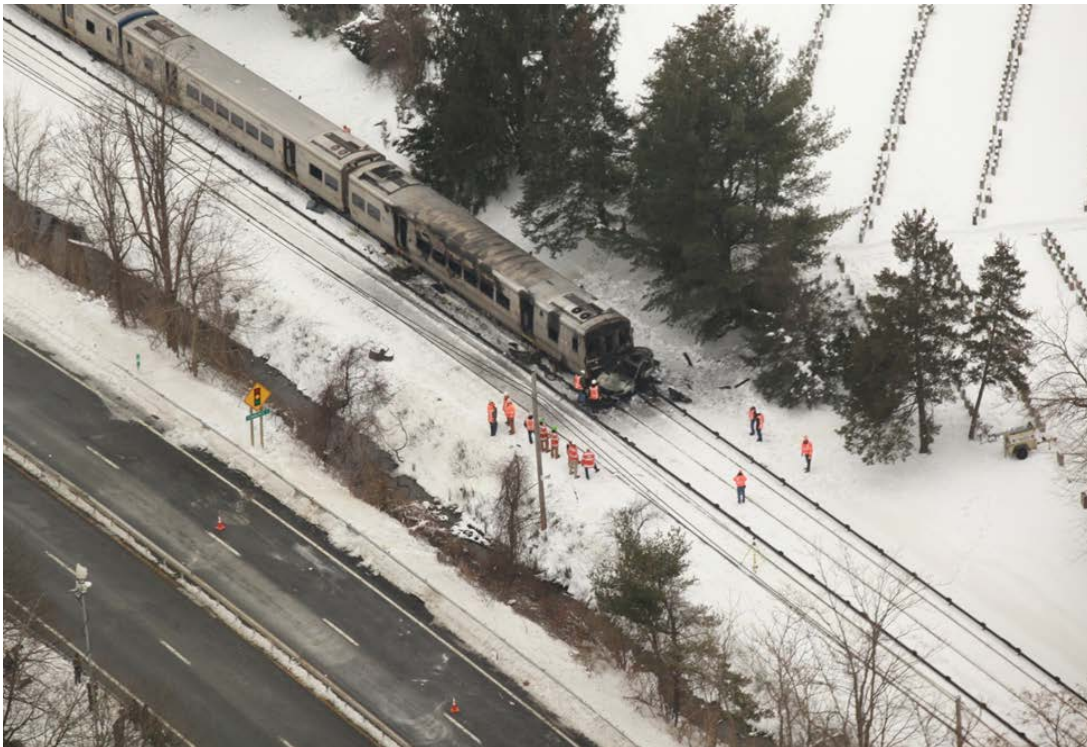
**Figure 1.** Train and SUV at point of rest following collision.

The train and the SUV continued northbound resulting in the damage of the electrified third rail on the west side of the track. The third rail detached, pierced the SUV, and then entered the railcar in two locations from the underside at the aft end of the left side passenger doorway. The train and SUV came to rest about 650 feet from the point of collision. An estimated 480 feet of third rail was damaged. Twelve sections of the third rail, each 39 feet long, were found inside the first passenger railcar.
