# PRELIMINARY REPORT

## HIGHWAY

### HWY14MH012

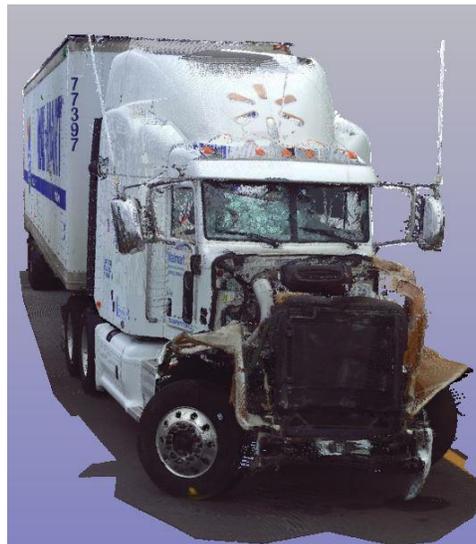
**Figure 1.** Three-dimensional scan of the Peterbilt combination vehicle involved in the June 7, 2014, crash in Cranbury, New Jersey.

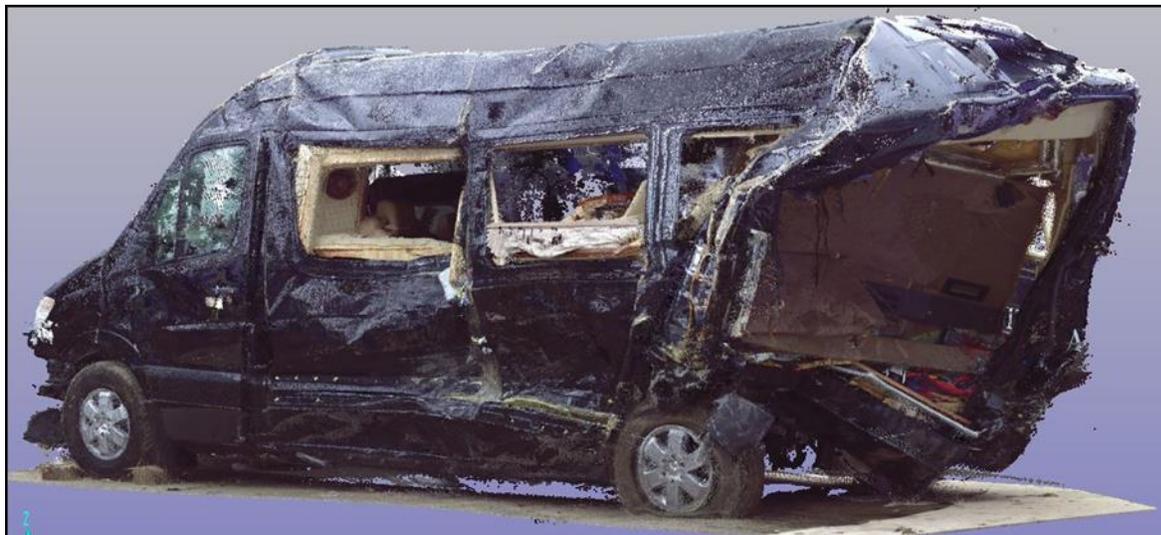
**Figure 2.** Three-dimensional scan of the Mercedes-Benz limo van involved in the June 7, 2014, crash in Cranbury, New Jersey.
